The Esco Group of Companies

Cleanability test on the 4 feet Labculture® Class II Type A2 Biohazard Safety Cabinets

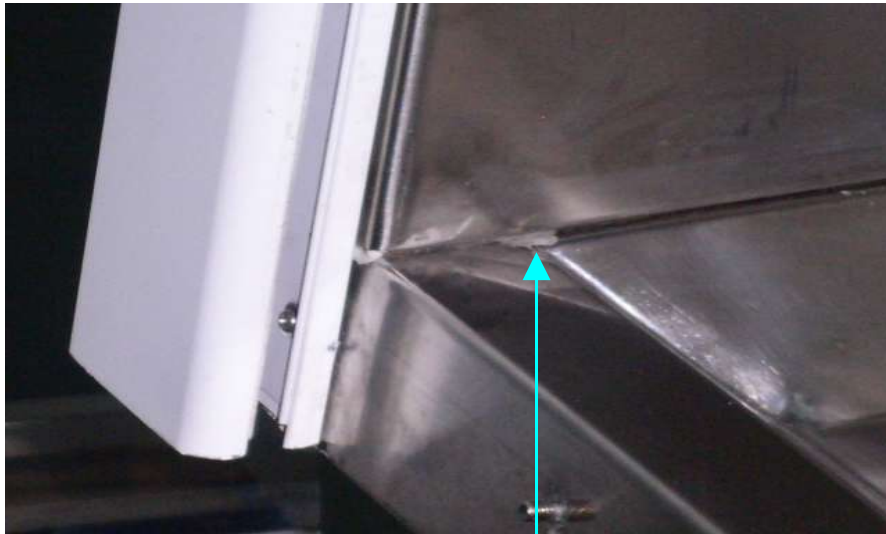
Drain pan 45°, front left corner

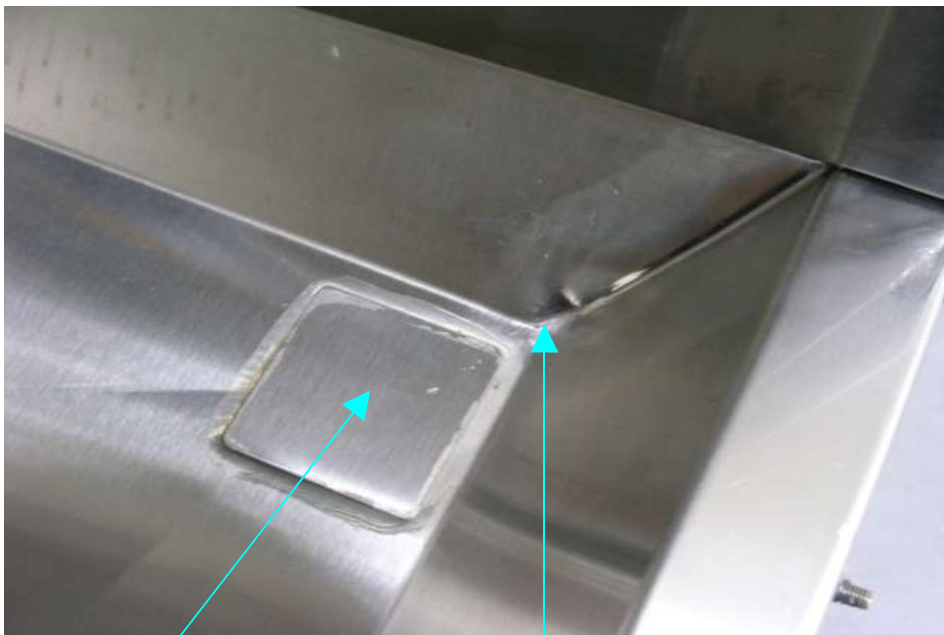
Drain valve plug

Drain pan 45° corner

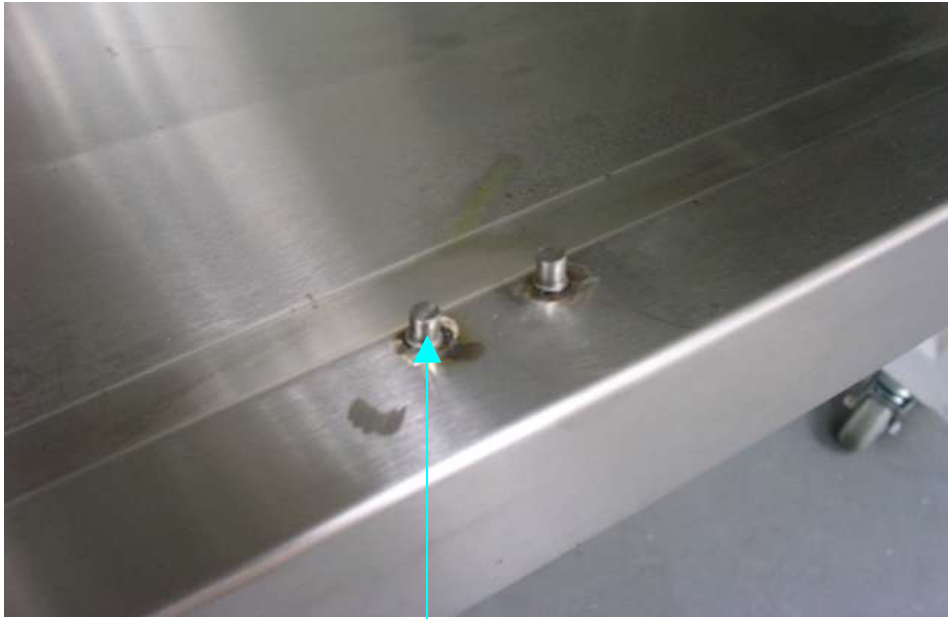
Front plain stud (to hold tray support bars)

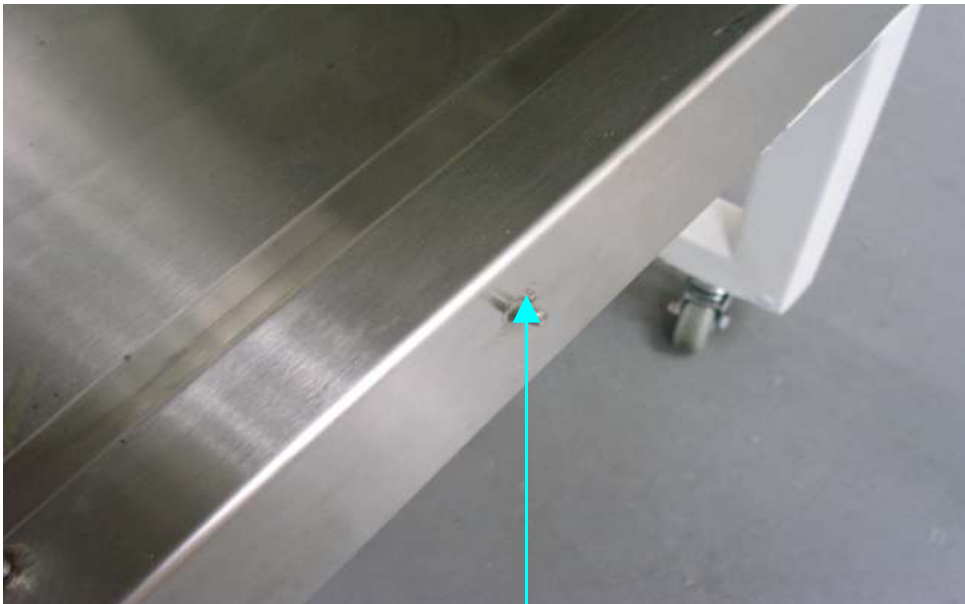
Front threaded stud (to hold arm rest)

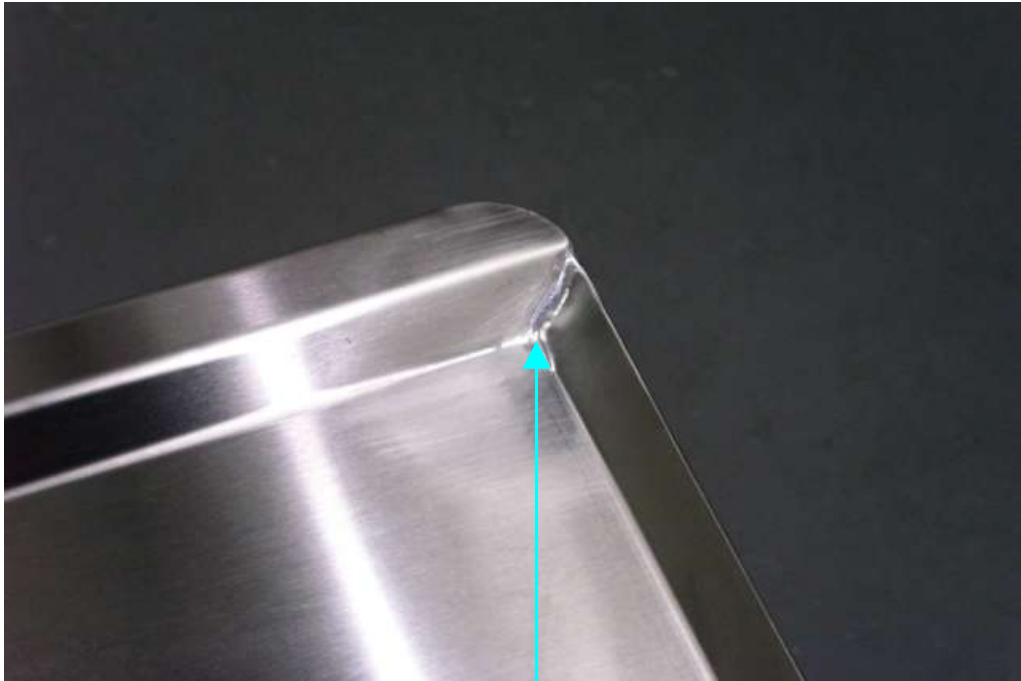
Tray 45° - back corner

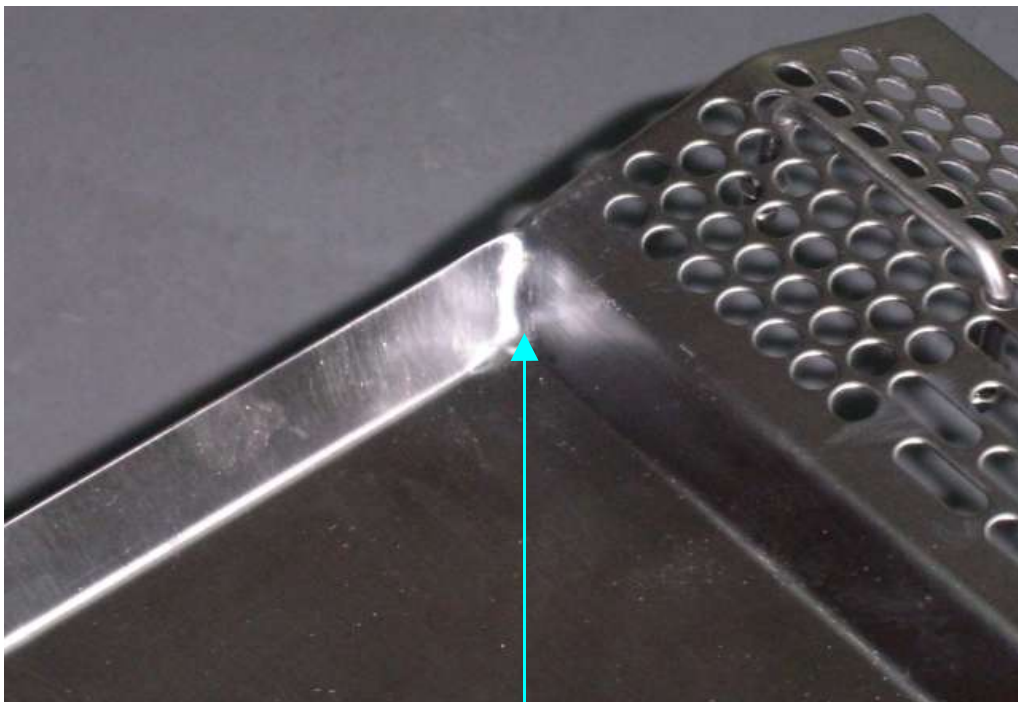
Tray 45° - front corner

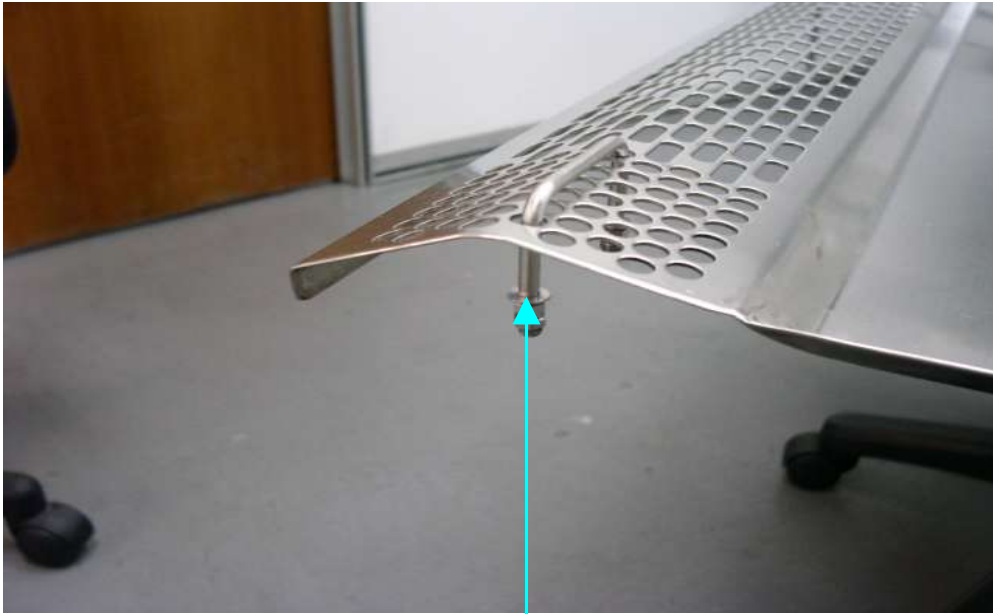
Nut on tray handle

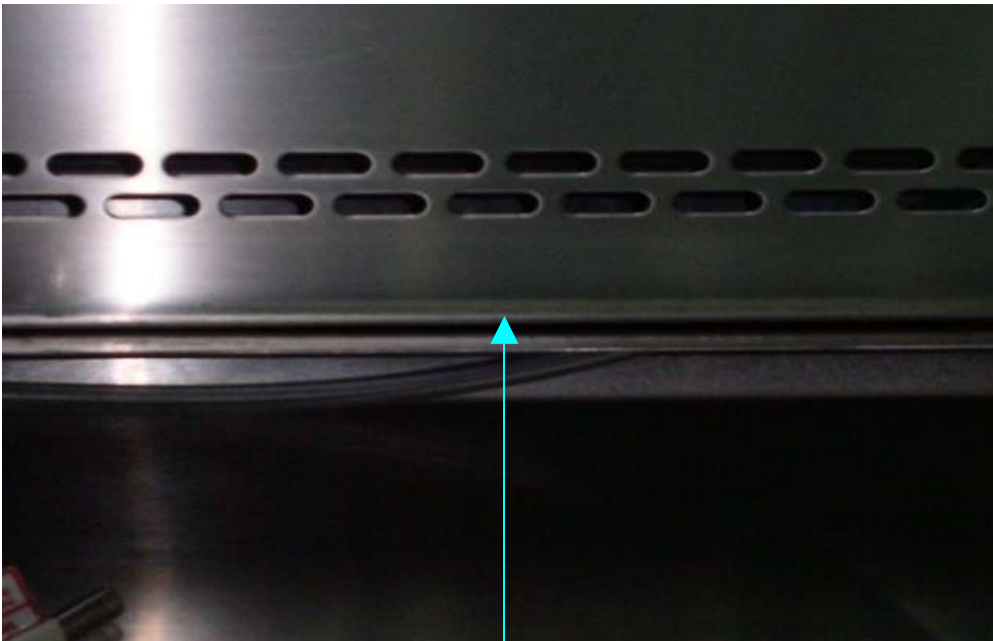
Tray support flange on the back wall

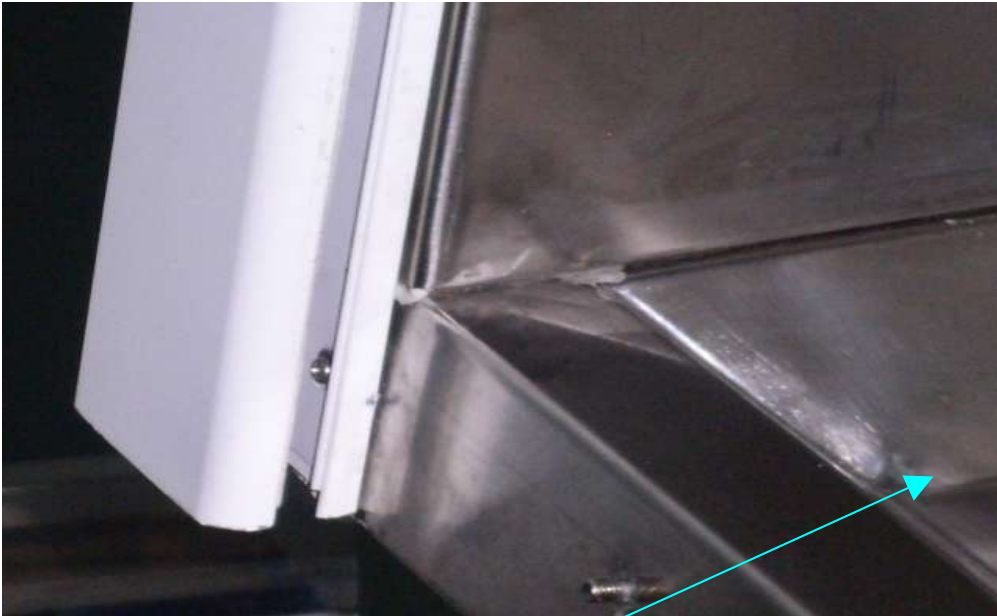
Tray 45° - front corner

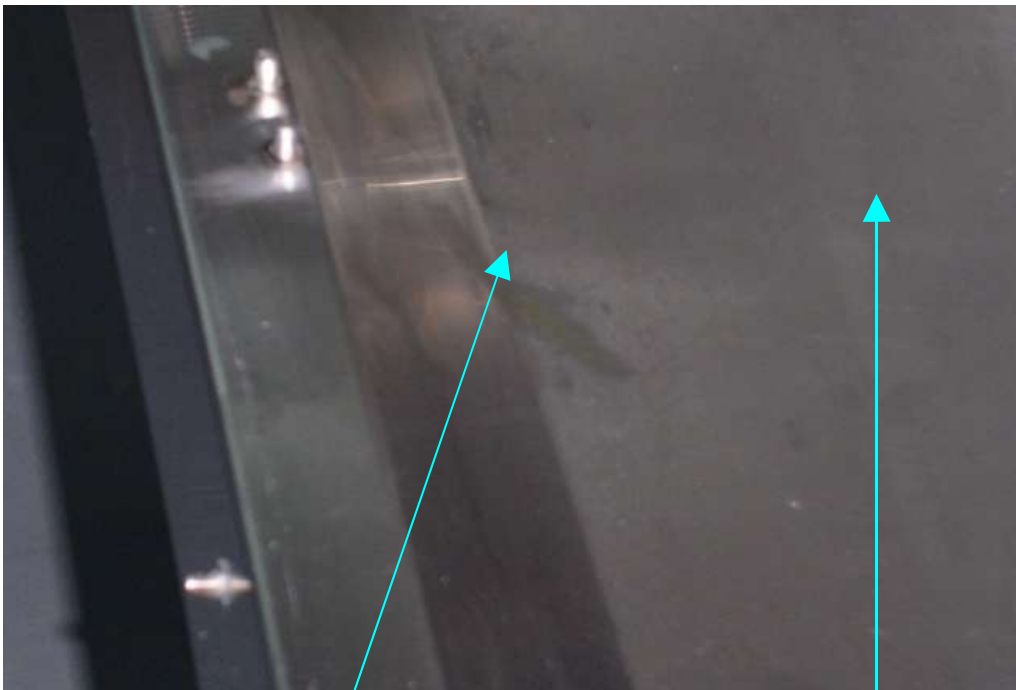
Drain pan – front bent

Middle of drain pan
